Apartment Complex Fire, 66 Units Destroyed Seattle, Washington

Apartment Complex Fire, 66 Units Destroyed Seattle, Washington (September 21, 1991)

Investigated by: Philip Schaenman

**This is Report 059 of the Major Fires Investigation Project conducted
by TriData Corporation under contract EMW-90-C-3338 to the United
States Fire Administration, Federal Emergency Management Agency.**

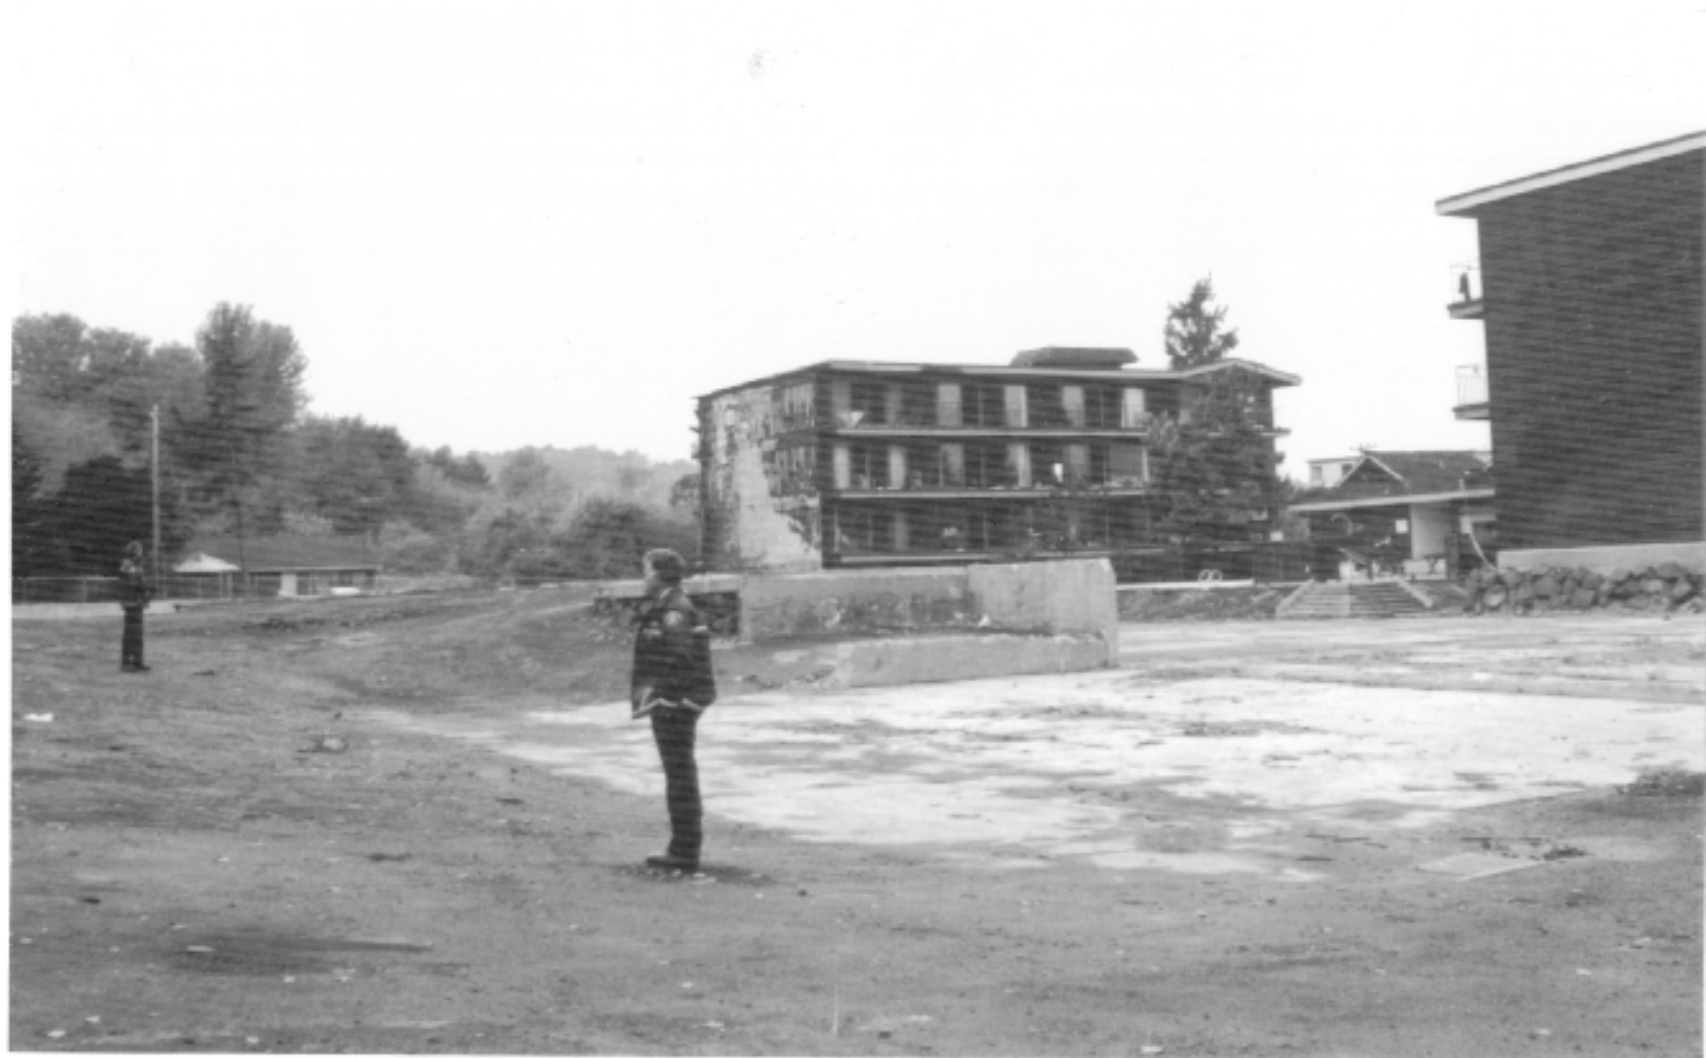
View of complex from southeast corner, looking northwest. The fire officer in the foreground is standing on the building line of what was Building D. The fire officer on the left is standing about where the first line and monitor were put into service by the first arriving engine company.

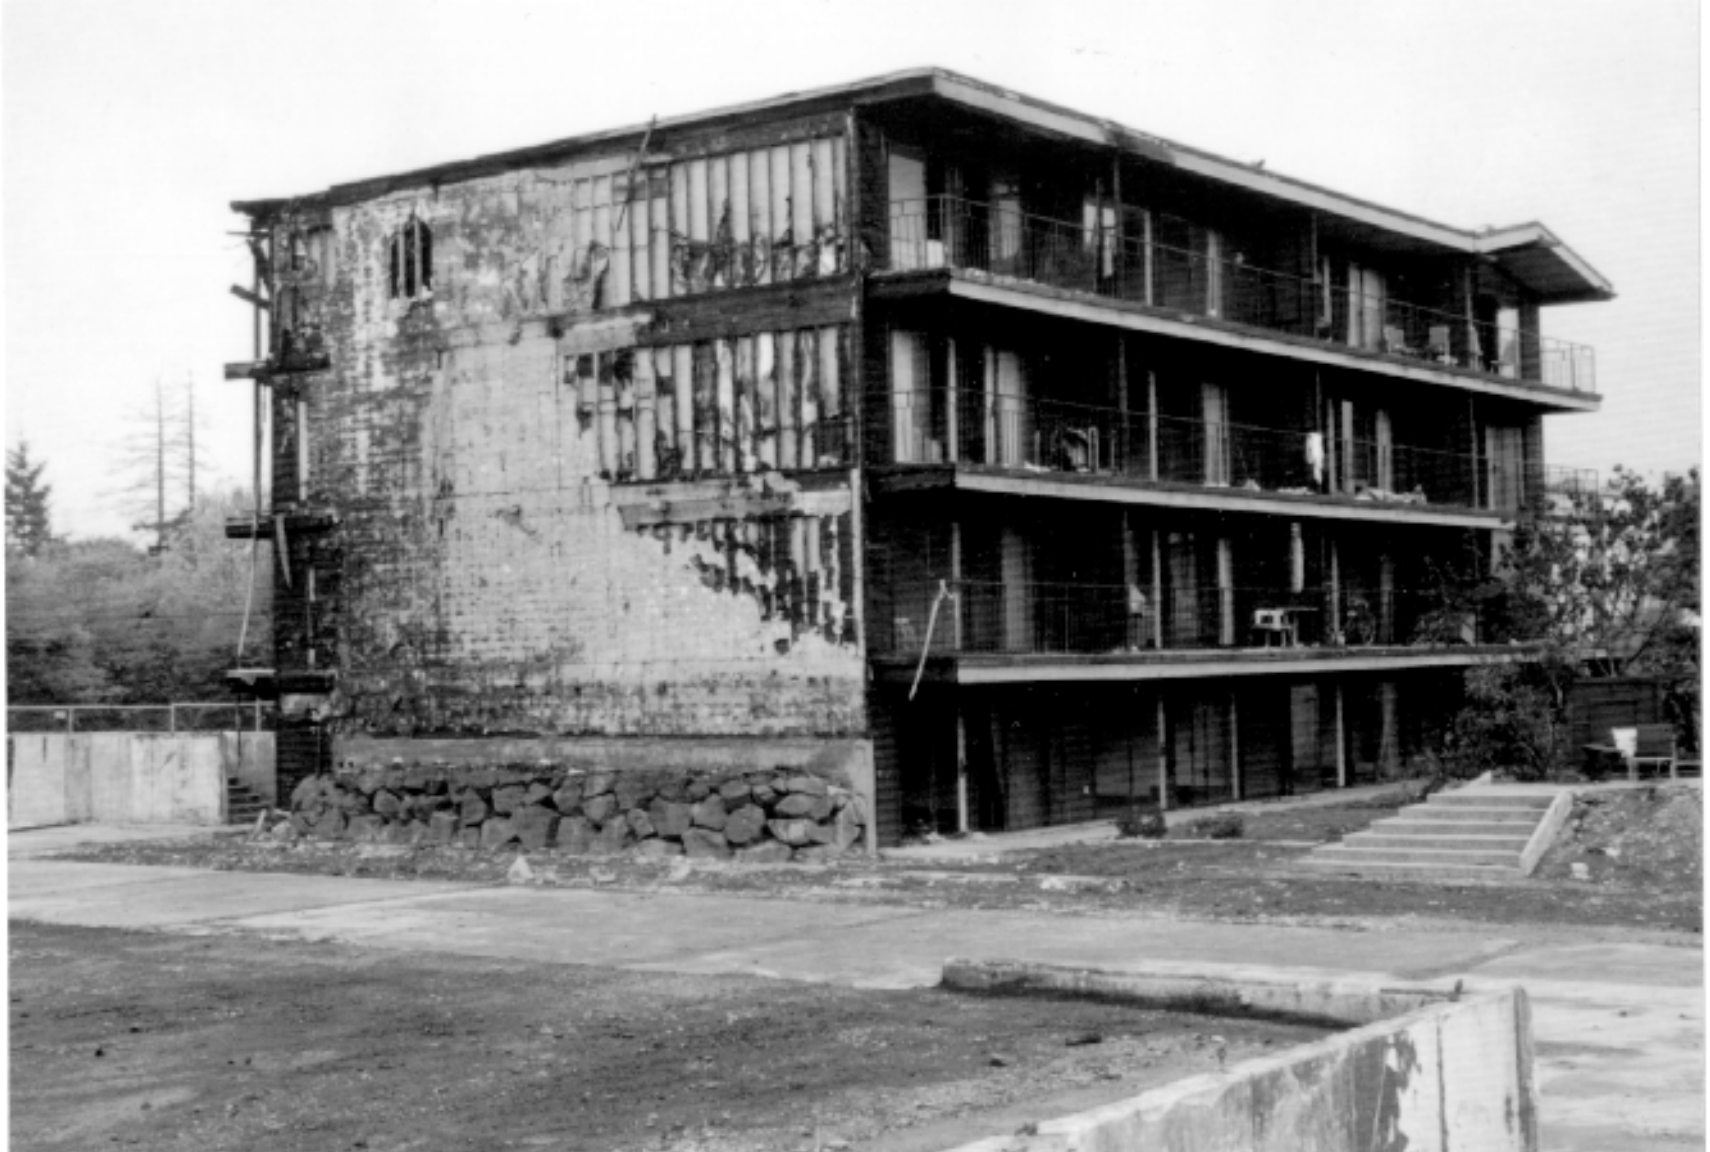
South and east sides of Building A. This building was saved by an excellent exposure defense. Note that it was burning on both its southwest and southeast corners.

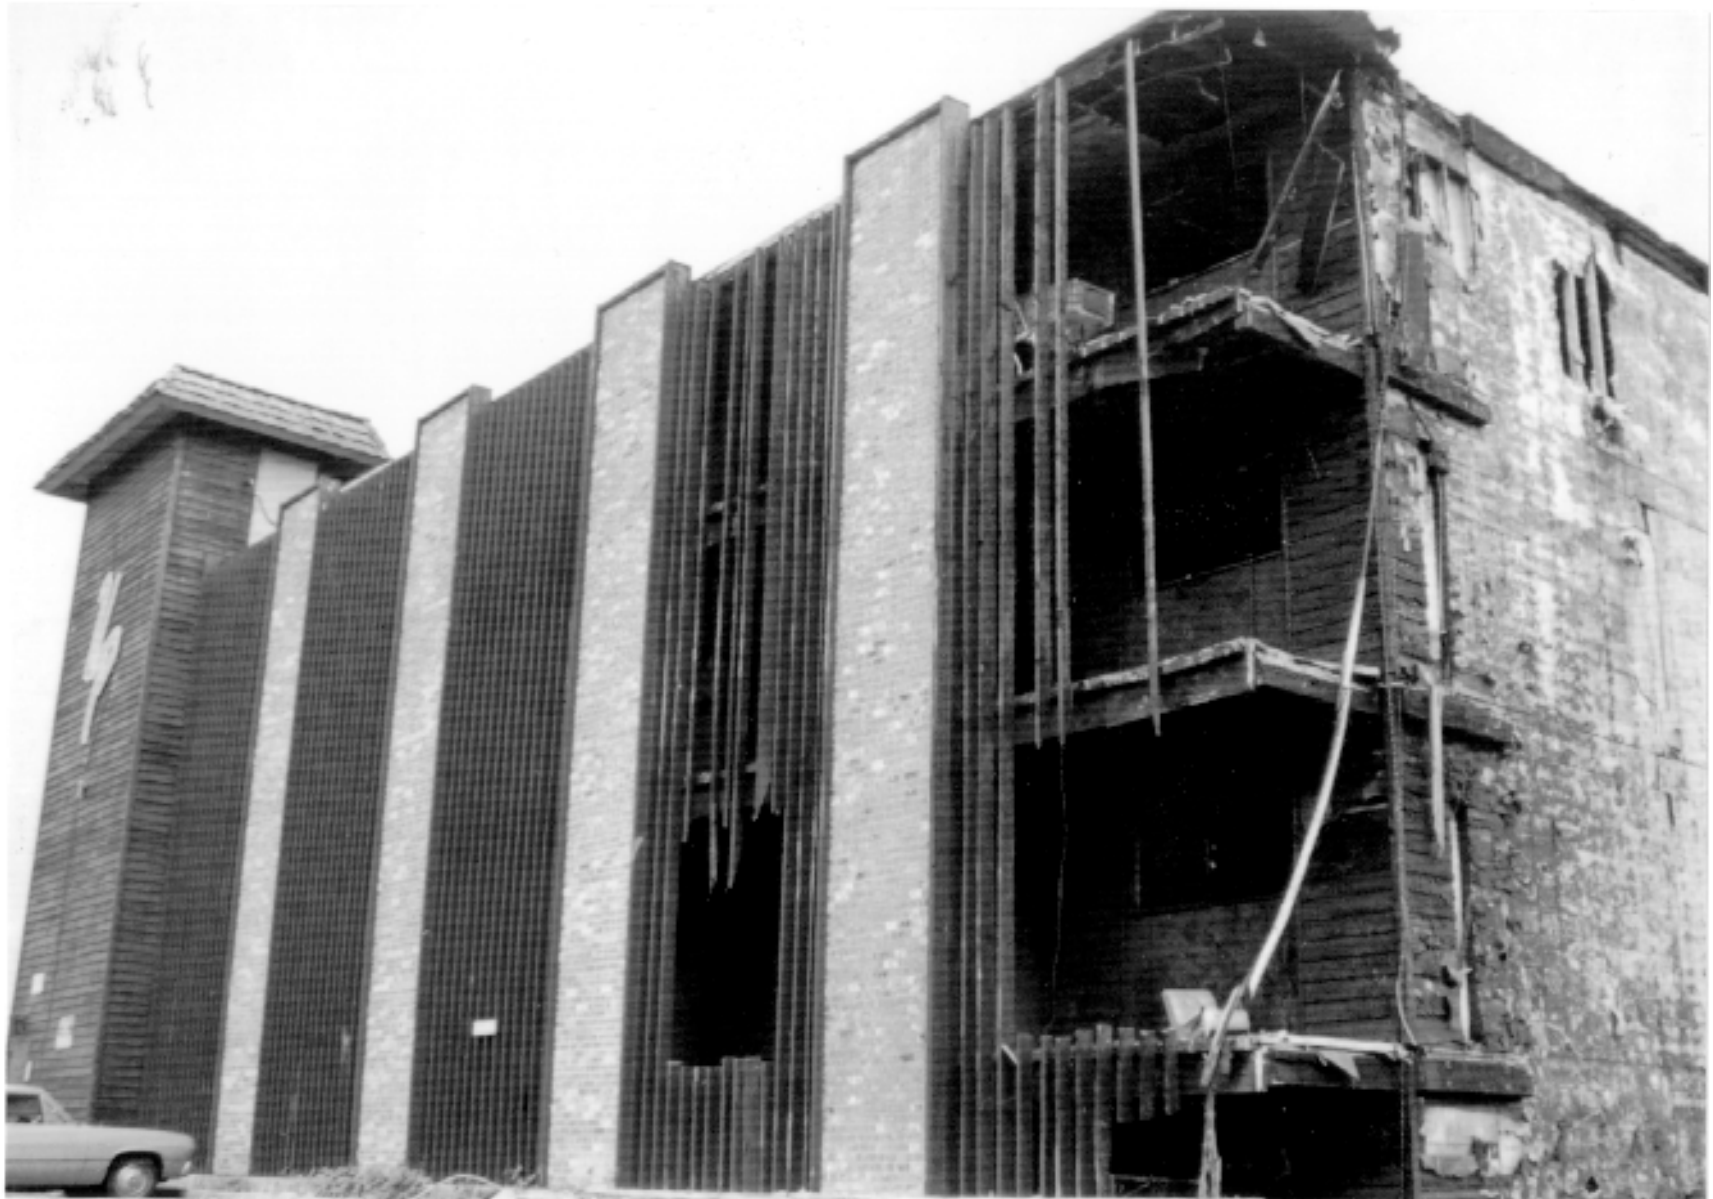
Close-up of west facade of Building A; its southwest corner was damaged.

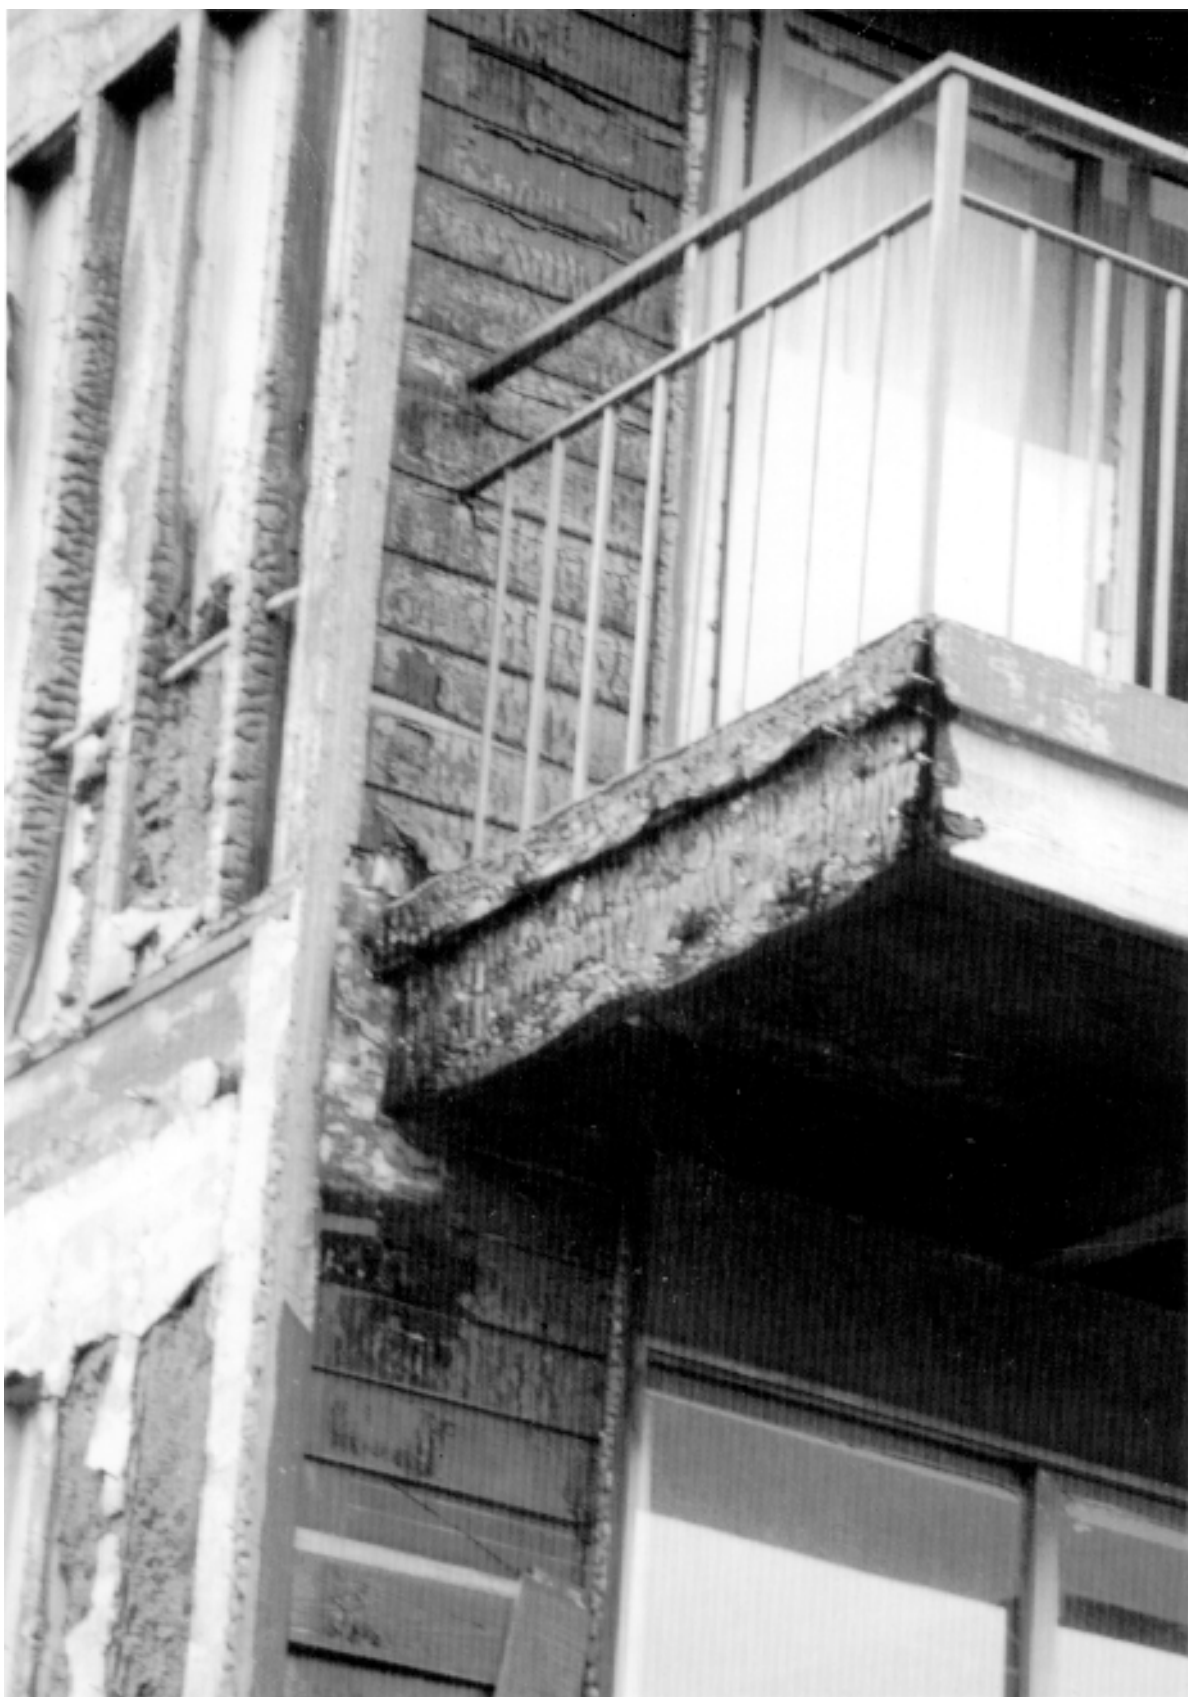
(Photo provided by Philip Schaenman)
Detail of southeast corner of Building A.

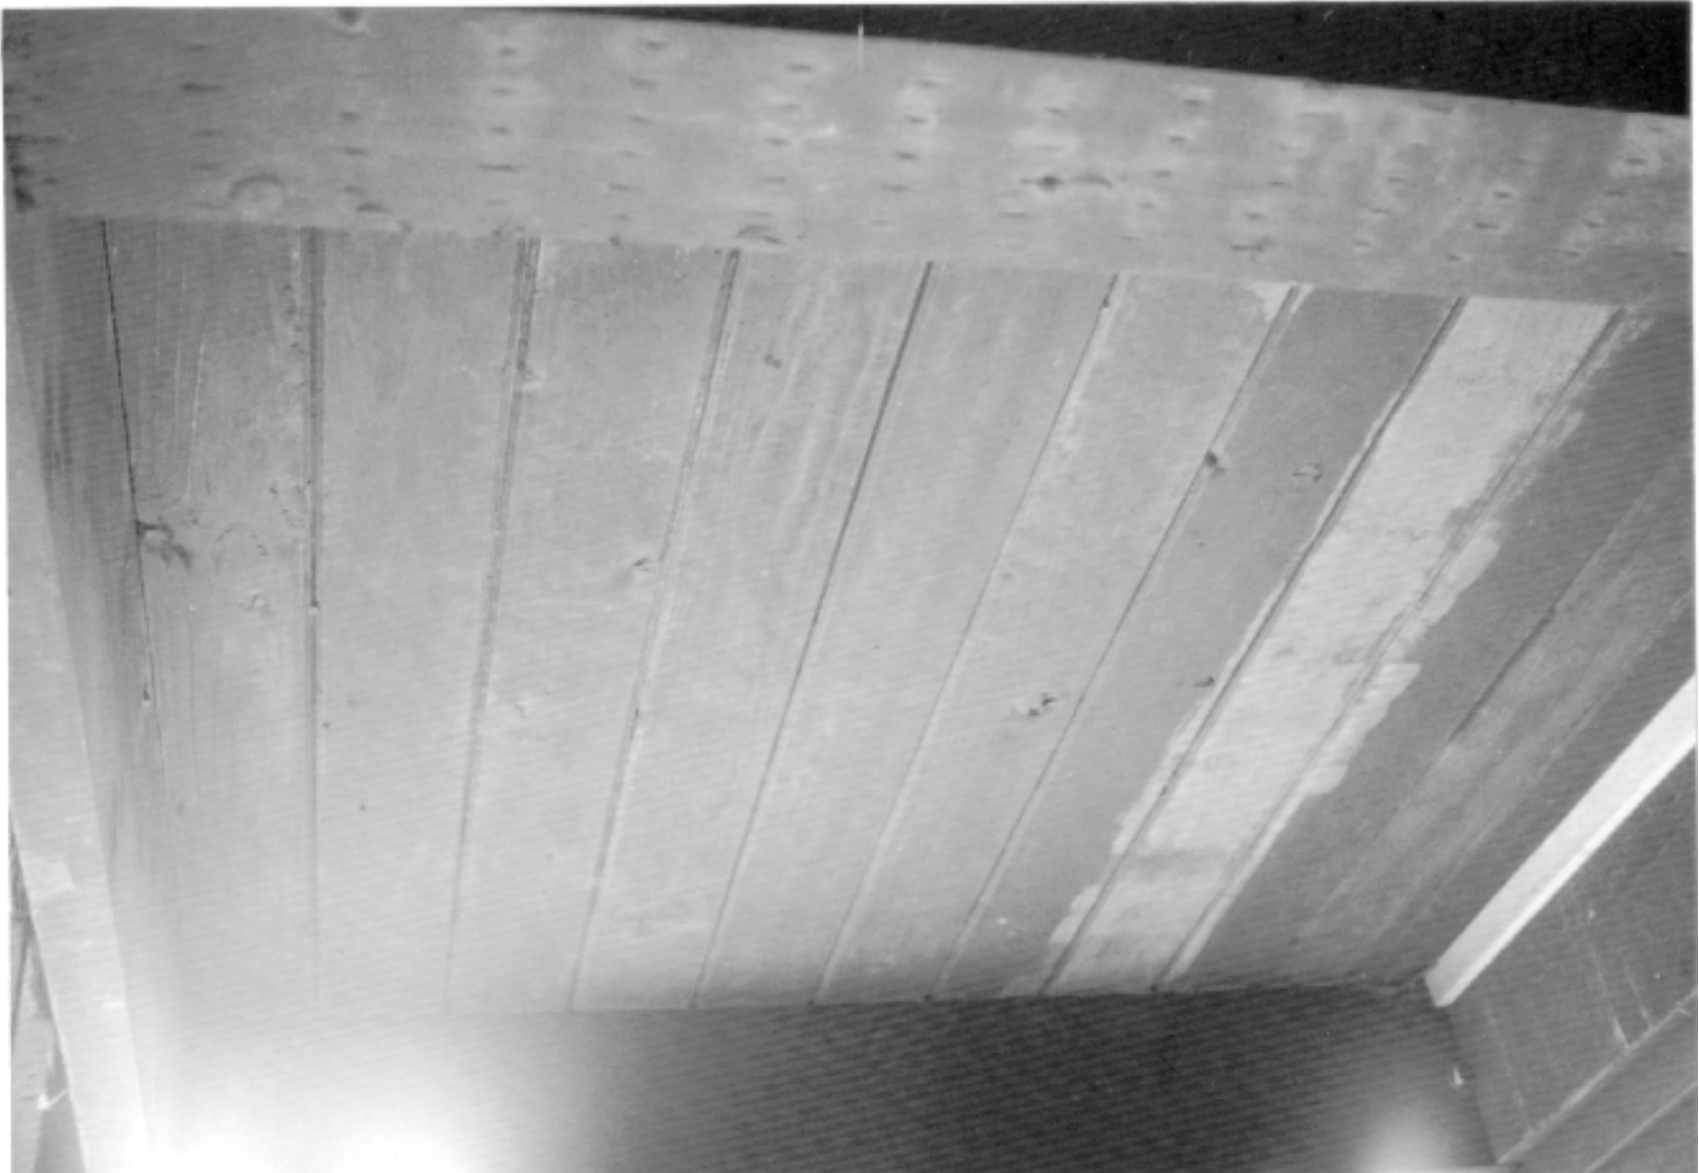
The ceiling of the exterior walkways on Floors 1-3 was an exposed tongue-and-groove cedar surface supported by 4" x 8" cantilevered wood beams. The walkways consisted of concrete covered by outdoor carpet. Fire doors had been retrofitted at intervals along the walkways.

Underside of walkway of basement level of Building E. The underside of all walkways on Floors 1-3 were similar and made of cedar. This was one of the avenues of flame spread.

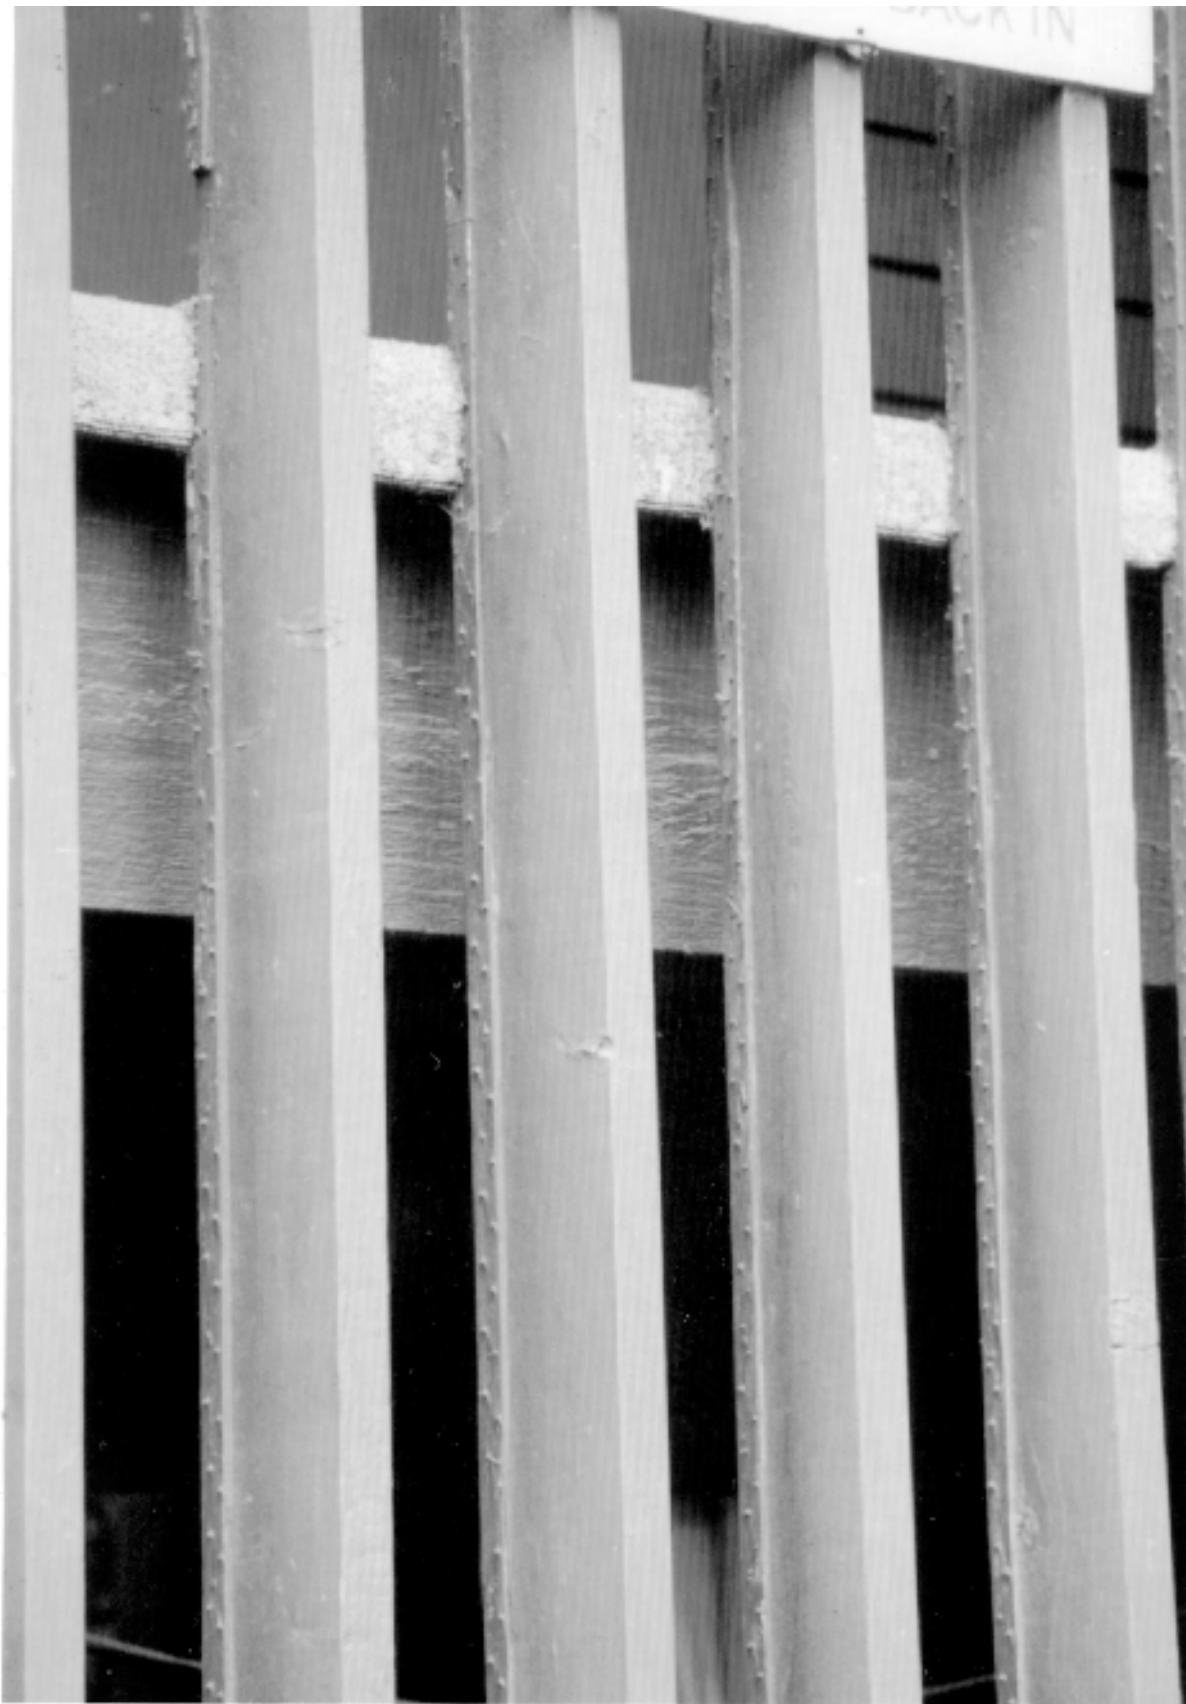
The fire coming out of the broken front bedroom window initially impinged on the base of the brick decorative fascia that separated segments of the cedar screen running up the face of the balconies. The screen was comprised of vertical 2x6's. It soon ignited and acted as a path for the fire to quickly extend vertically up the entire 40-foot face of the screen, and also horizontally across the screen. The fire also quickly ignited the cedar siding and cedar underside of the walkway ceilings. The fire spread both east and west on the face of the building.

Close-up of the decorative cedar screen on the fronts of the buildings, which served a security purpose as well. Fire could race unimpeded up the wood 2 x 6's. The photograph shows the screen as it passes the outdoor carpeted floor of the walkway above.

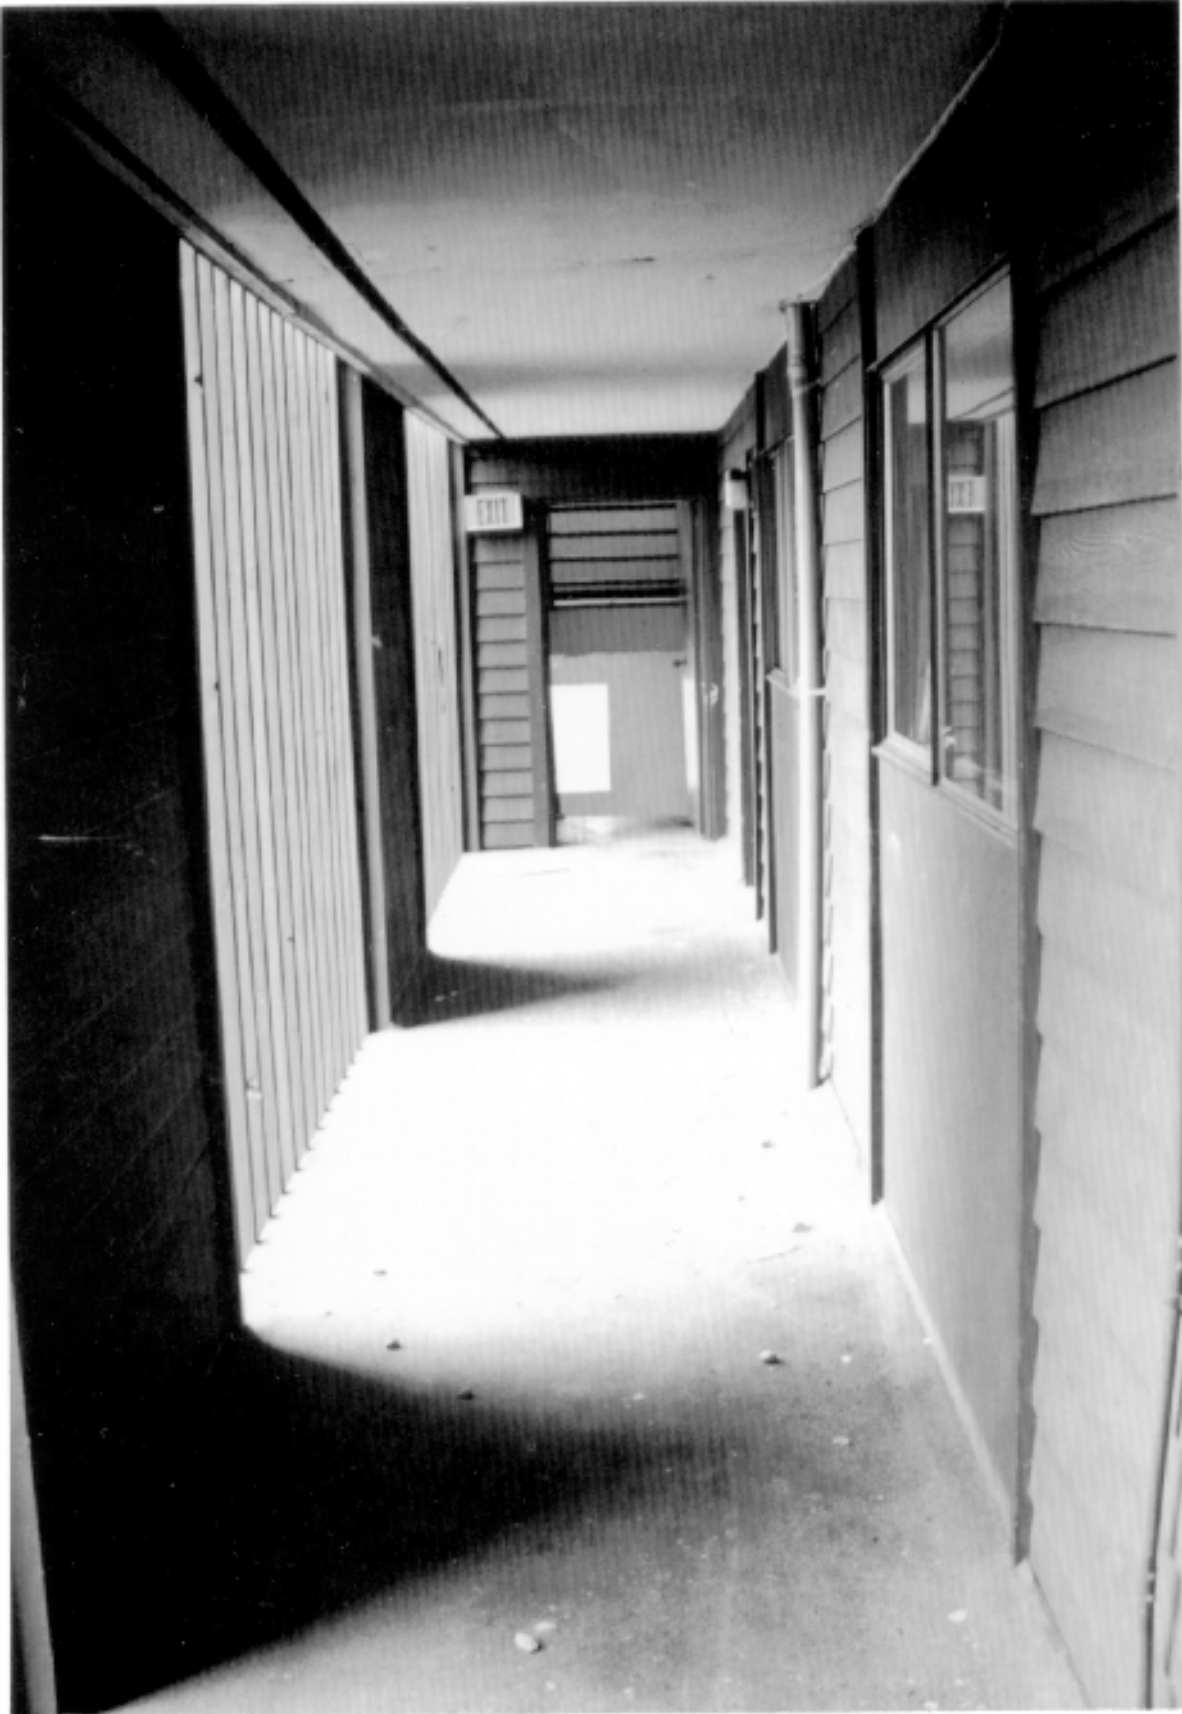
Top (fourth) floor walkway on western exterior of Building A. The ceiling of the fourth level was the only one not of cedar. The window shown is a bedroom window like the one that first blew out in the apartment of origin.

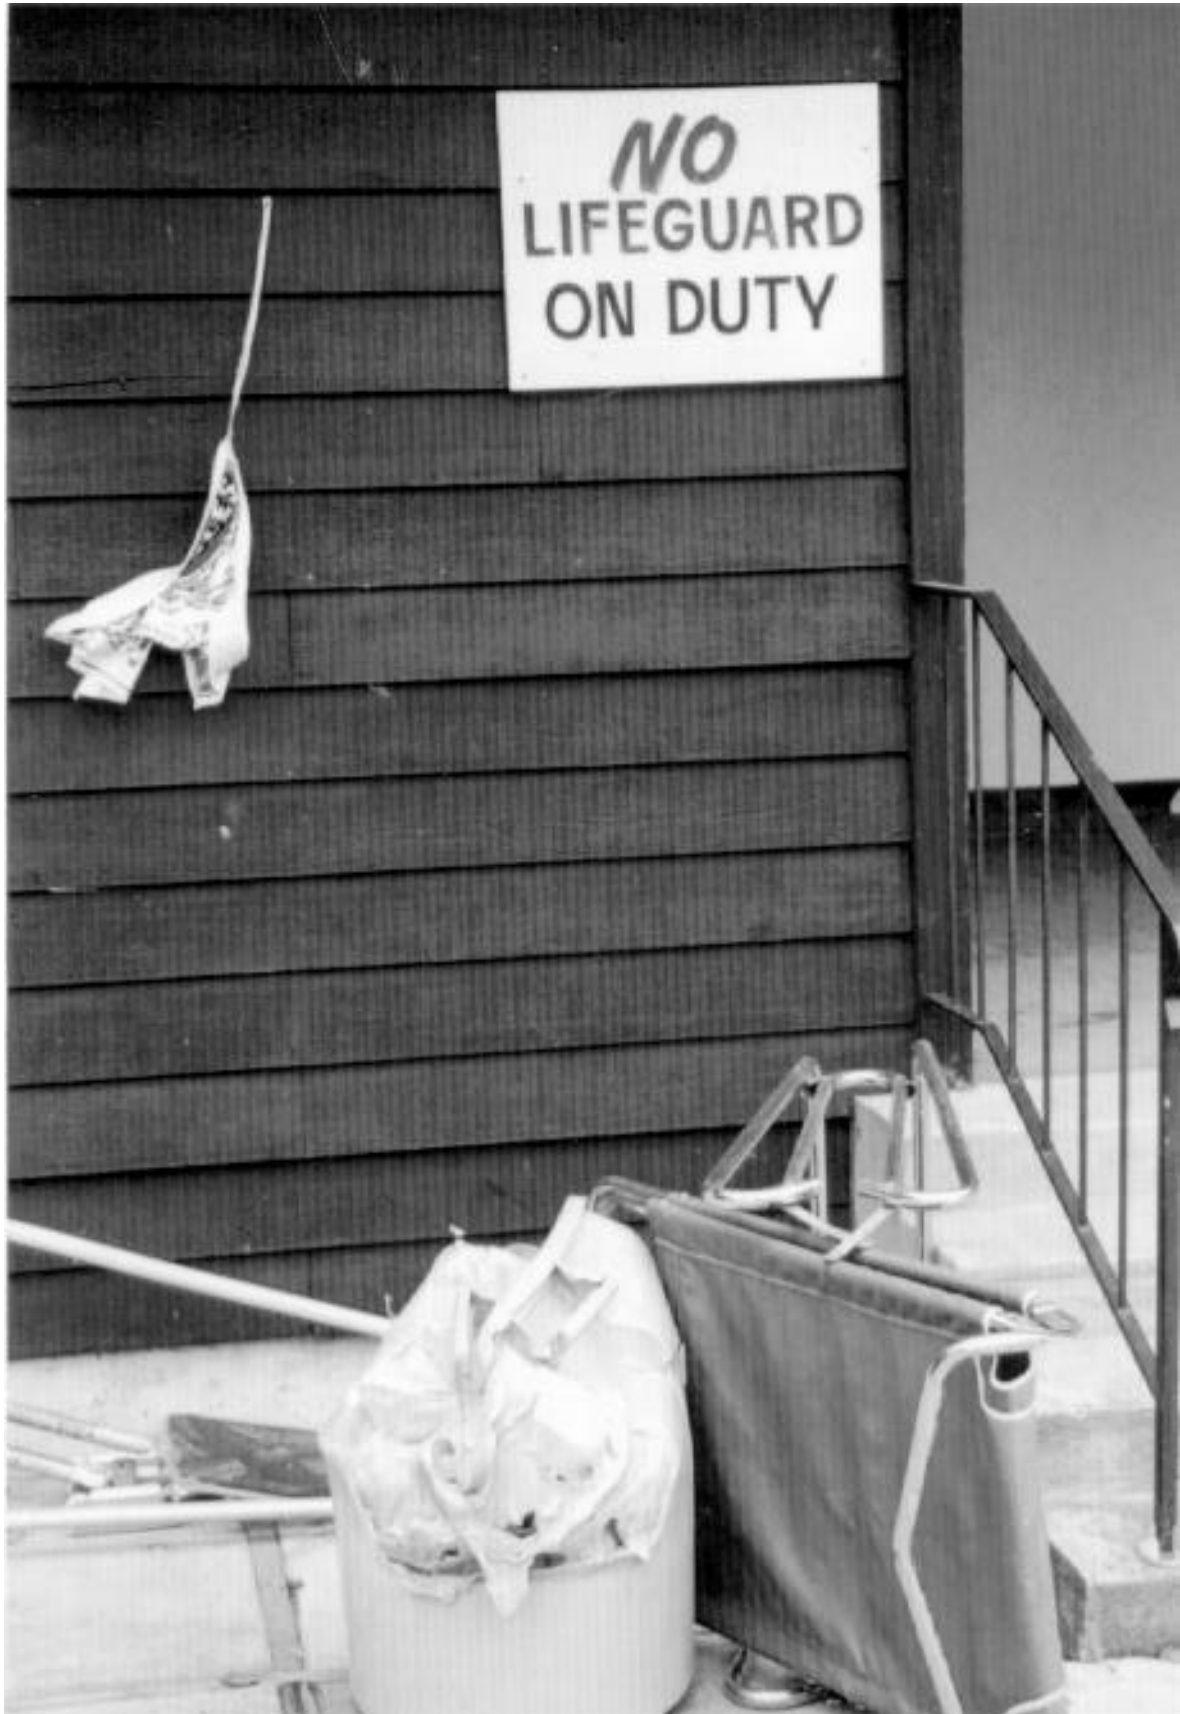
Melted plastic containers behind the swimming pool. Firefighters were operating in this area during the initial stages of the attack.
